Punta Raton Beach

Slope Erosion Control

Beach Properties, San Carlos, Panama, Republica de Panama

Case Study

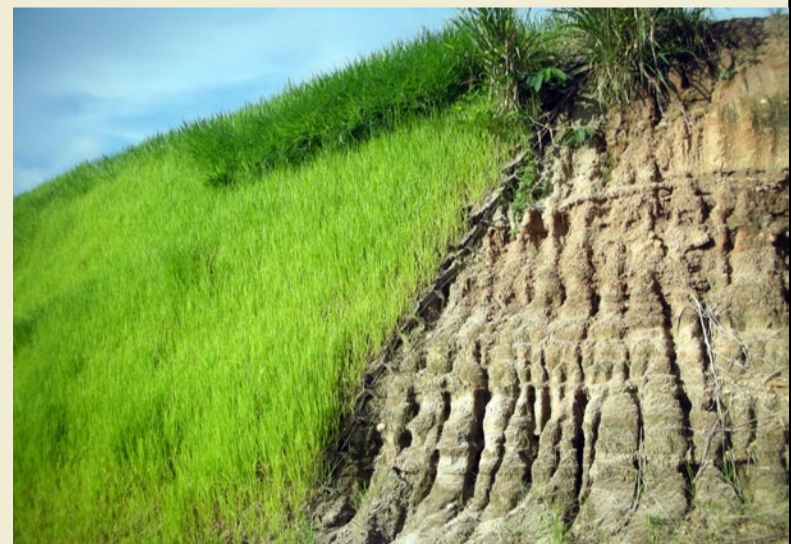
Finished Project showing termination of material
(Left is complete, Right is original slope)

Construction began on the slopes, which were considered in critical condition at the time of the project. The soil in the area was very unstable, loose, and sandy. They proceeded to install the EnviroGrid material on the slopes, using a dead man anchor at the top connected to polyethylene tendons to support the material and prevent sliding. The cells were then filled with sandy soil. At times, this process was impossible with heavy machinery and the cells had to be filled by hand. After compacted, the slopes were hydroseeded with the root medium Brachiaria (by Hydro-green of Panama) and several days were given to allow the vegetation to grow.

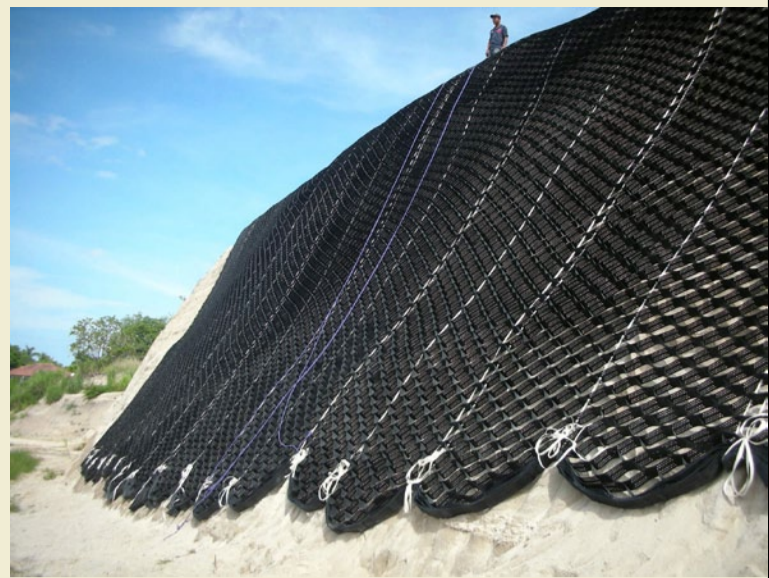
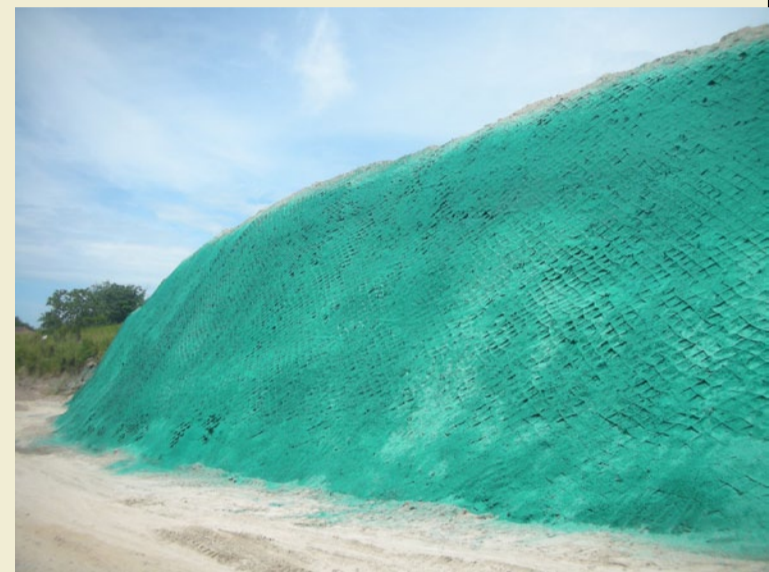
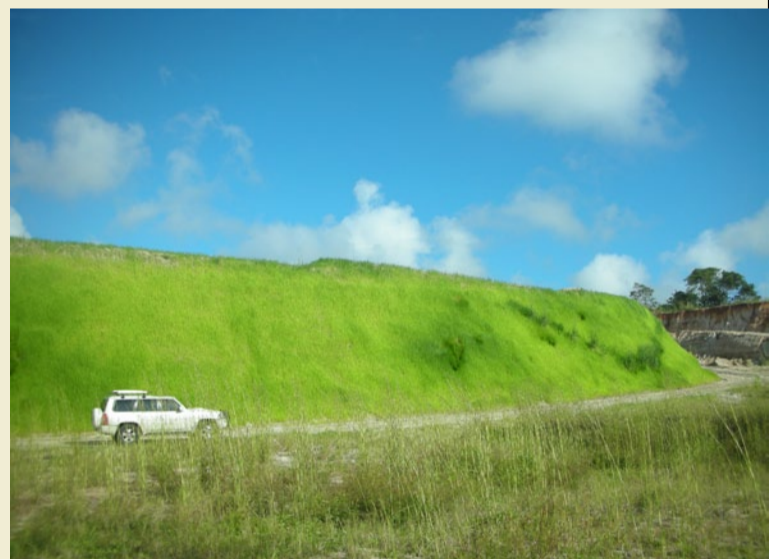
After 8 days of watering, vegetation began to take root and by 3 weeks abundant vegetation had grown on the slopes. The problem was solved. The EnviroGrid cellular confinement system impeded further erosion and confined the soils on the slope to allow grass and other vegetation to grow,
