# Bijao Beach Resort

## Slope Erosion Control

Case Study

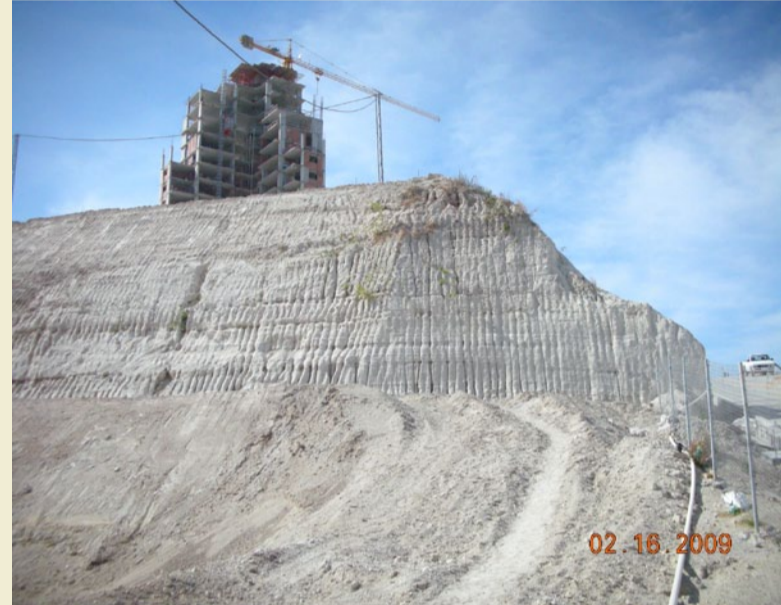
The Bijao Beach Resort community resides in the balmy region of Panama near Santa Clara's beaches. It was constructed as a luxury resort to compete with nearby Playa Blanca and Decameron. An artificial mountain was created to enhance the geography of the resort. Native soil of the area was compacted and stabilized with biaxial geogrid, but rain has wreaked havoc upon the slopes. Severe erosion has caused extremely large ruts to form in the sides of the mountain which threaten its integrity.

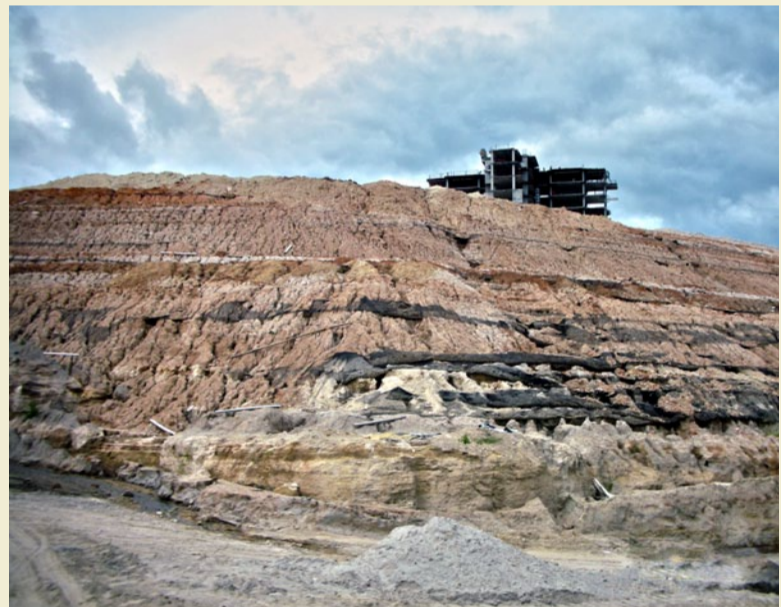
Bijao Beach Resort  
(Pre-Envirogrid Slope Erosion Control System)

Initially when the mountain was developed biaxial geogrid was used as stabilization, but as the rains eroded away large portions of the slope it was determined that this material was inappropriate for the application. These slopes were extremely steep, measuring sixty-five to seventy degrees, and lacked any type of vegetation. The opening date of the resort set a narrow time frame for completion of the project and forced contractors to find an aesthetically pleasing, quick solution that would efficiently solve the problem without excess cost.

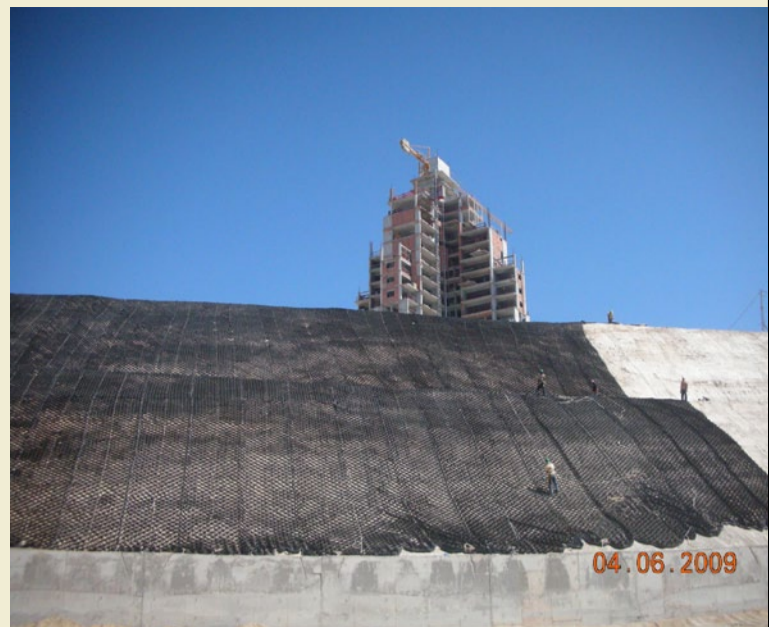
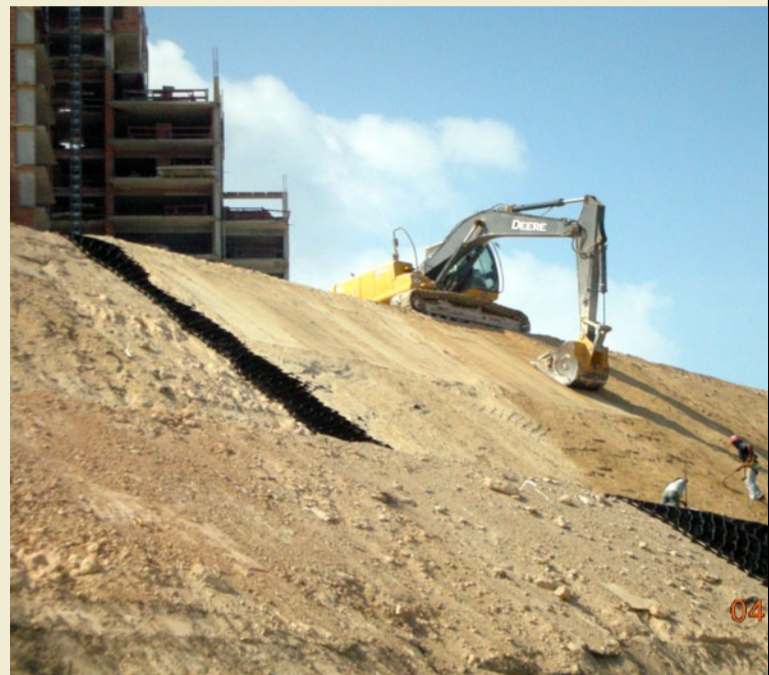
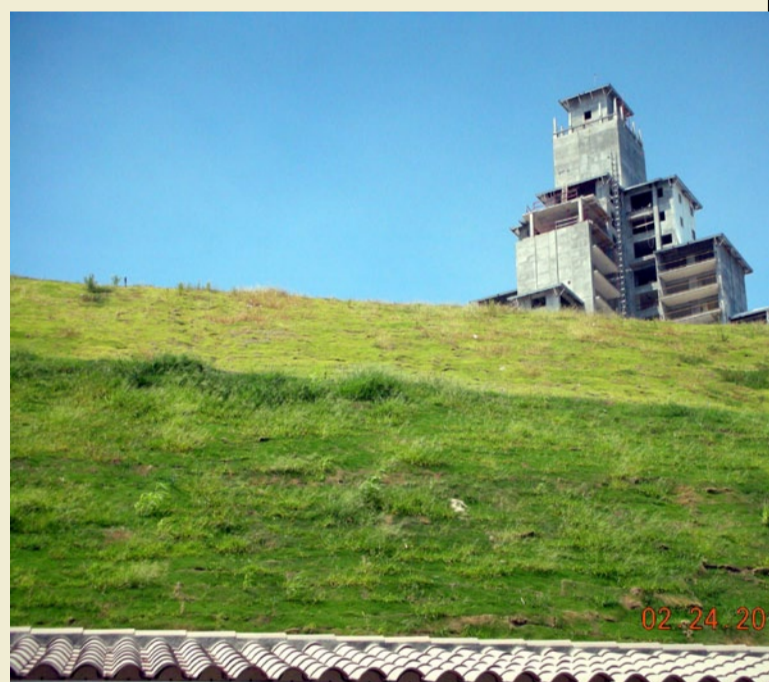
A 4" perforated EnviroGrid 3D cellular confinement system was used and placed directly on the slopes. The EnviroGrid panels were anchored in place with polyester tendons along the entire slope including the 5 meter shelf area. The tendons were dead-man anchored at the top of the slope and adjacent panels stapled. The EnviroGrid was filled with local sandy soil and hydro seeded with Saint Augustine grass seed. The 4,500 m<sup>2</sup> of EnviroGrid were installed in 2 weeks by a crew of eight men.

After construction contractors continued to irrigate the slope, preventing additional erosion within the cells while the vegetation was taking root. At 4 weeks, abundant vegetation growth was observed and responsible gardeners kept the slope hydrated.
