El Valle del Anton

Retaining Wall

Rio Jesus km20, Panama, Republica de Panama

Case Study

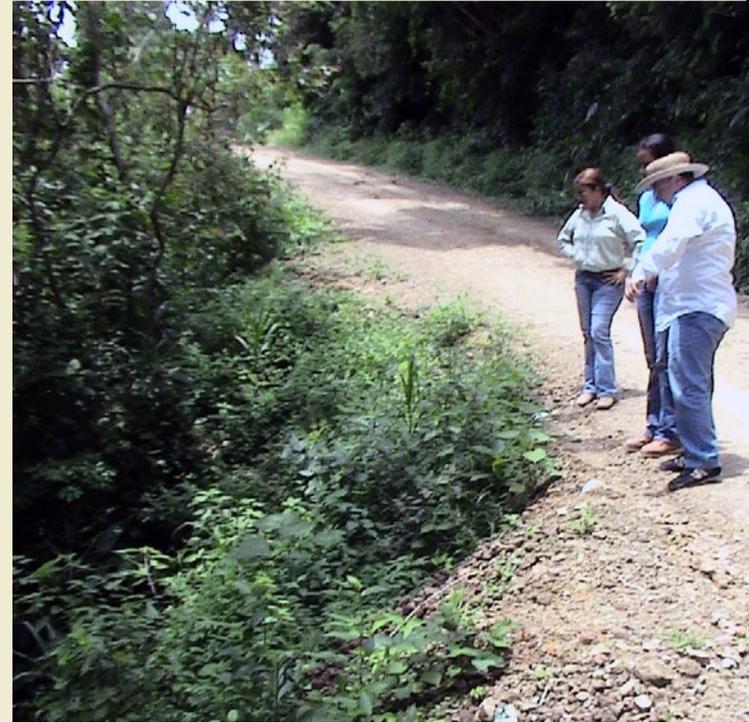
Embankment along the Rio de Jesus River village road
(Prior to installation of Envirogrid Retaining Wall)

The Rio de Jesus runs through El Valle De Anton, a very mountainous region in central Panama. These conditions, coupled with heavy seasonal rains, cause severe damage to roadways and embankments in the area. Erosion and instability from shifting soils, periodic landslides and mud-slides plague the valley daily and were beginning to affect construction.

The Ministry of Public Works in Panama could not authorize work to commence on km20 of the Rio de Jesus Village road due to erosion of the road and adjacent embankment. In order to permit vehicle traffic, 2.5m of road had to be added to the existing track width.

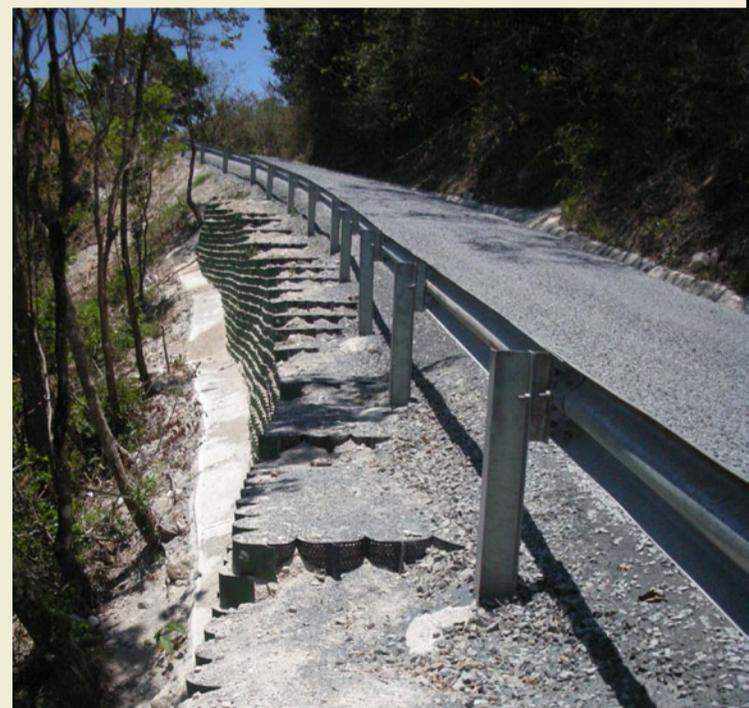
Finished Project, showing the widened road and
Retaining Wall along the embankment.

The Envirogrid geocell system formed a retaining wall that was structurally resistant to any loads applied and seismic movement in the area. The objective to increase the width of the road was met and the road was opened up to vehicular traffic. The expansion of the road was of great importance because it was the only way for local citrus farmers to transport goods to the Capitol.
